Appendix I: Artefacts and Trouble-shooting

Slide set of 101 slides based on the chapter authored by E. Busemann Sokole, N.J. Forwood of the IAEA publication (ISBN 978–92–0–143810–2): *Nuclear Medicine Physics: A Handbook for Teachers and Students*

To familiarize the student with trouble-shooting methods, problem minimization, and recognizing the cause of artefacts that may be encountered in nuclear medicine imaging systems

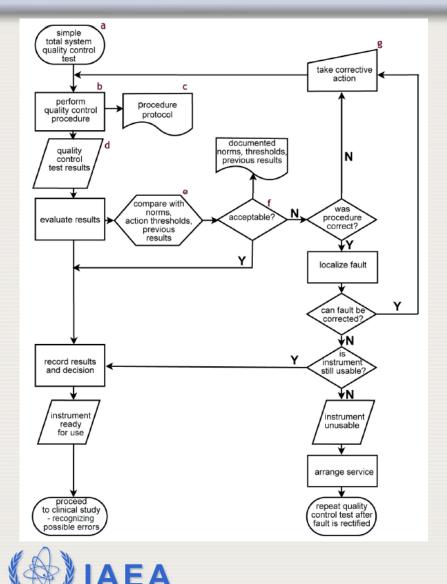
Decision tree suggested for performance, evaluation and follow-up of a QC test.

- Malfunctions can occur at any time, even during a patient investigation.
- The actions in this case should minimize the distress to the patient, identify the problem and correct it, if possible, and decide what to do with the investigation (continue, do it on another instrument, reschedule, or other).
- Action flow-charts are useful in the decision making process. An example is shown in the next slide, following a QC test.

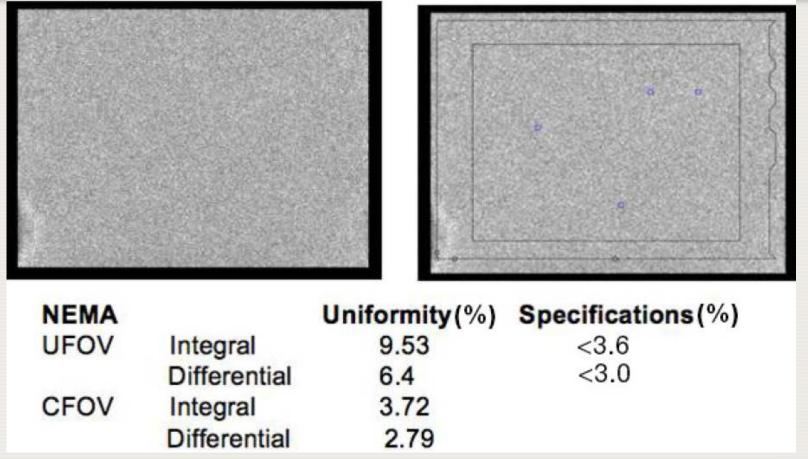
The defect affected imaging at the edge of the field of view. This detector could therefore still be used for imaging within the central field of view.

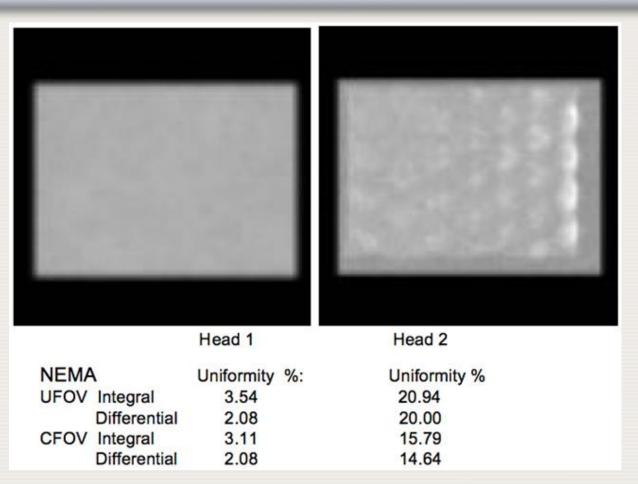
The non-uniformity of head 2 was extensive and thus imaging with this detector had to be suspended until the problem was solved.

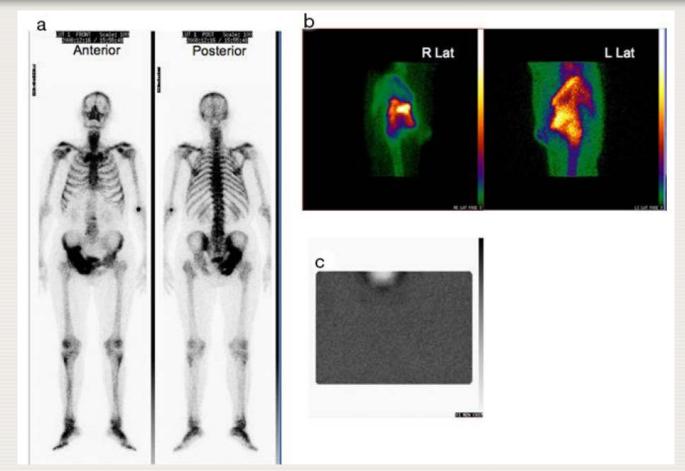
Defect was found during a routine QC test. This camera required a service, but could still be used with caution for planar imaging within a limited part of the detector.

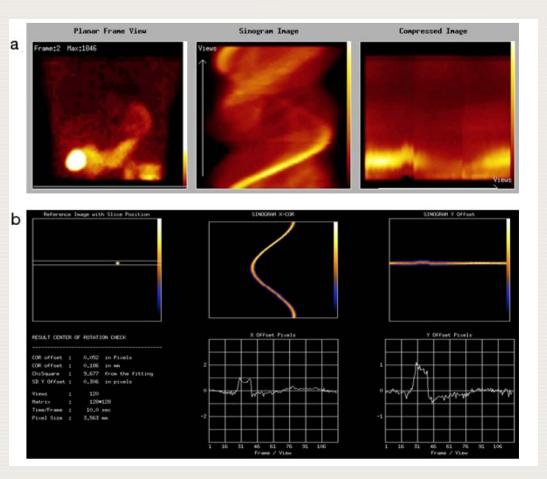
Abnormal quantitative results

Offsets are seen in both X and Y in detector 1 data, identified clearly by the jump in offset in both X and Y on the quantitative analysis.

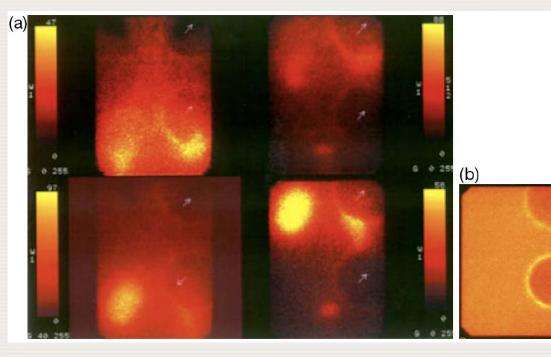
Uniformity defect due to PMTs

(a)Each image of the clinical study showed two large, diffuse, circular colder areas (indicated by arrows).

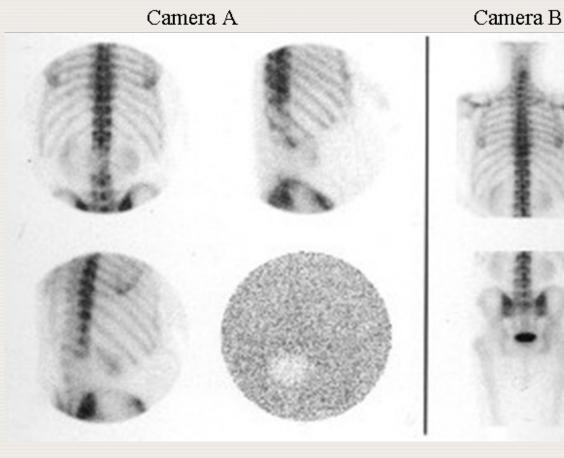
Uniformity defect due to PMTs

In camera A an area of apparent decreased activity is observed in the lower spine . Repeated study on camera B shows a normal distribution. Uniformity image of camera A demonstrates defective PMT.

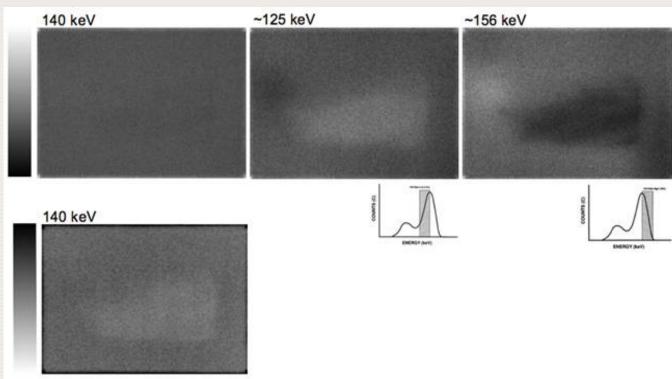
Asymmetric images

Early appearance in asymmetric images of defect, that 6 months later appears in the symmetric image, attributed to separation of the light pipe from the crystal.

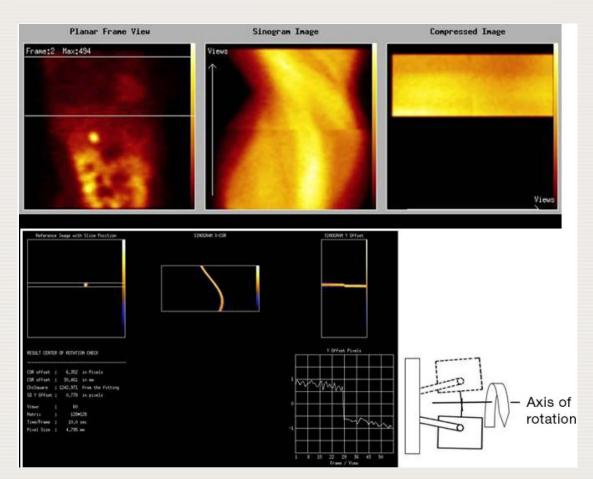
Head tilt problem

QC following recalibration of camera head alignment, showing a remaining problem of head tilt.

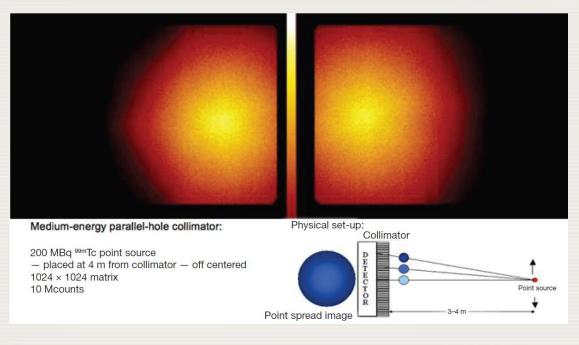
Acceptance testing findings

Collimator tested for hole angulation at acceptance testing. There are vertical discontinuities evident, probably from the manufacturing process. This collimator was replaced within the guarantee period.

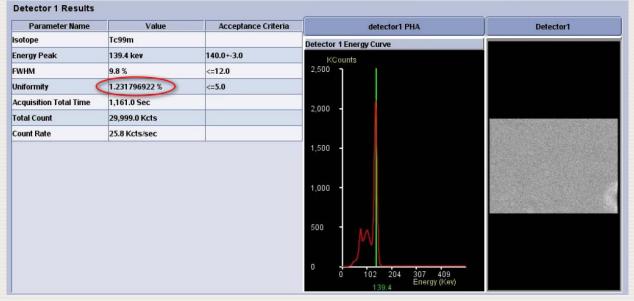
Visual inspection and quantitative data

In the uniformity test, the quantitative uniformity value appears to be acceptable, whereas the image shows there is a PMT problem at the border.

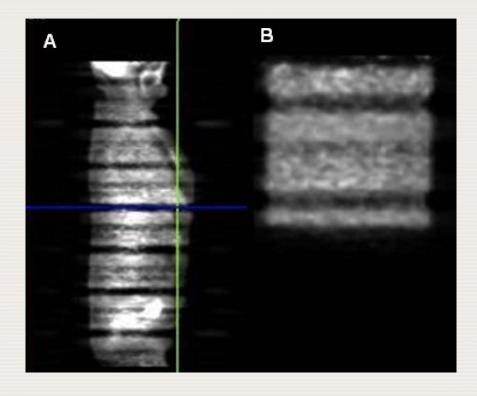
Artefact from normalization errors

(A)Clinical whole body images obtained on a PET system.(B)QC image of a uniformly filled cylindrical phantom, showing streaks indicative of errors in normalization table.

- The daily quality assurance routine is a good way to detect unexpected sudden normalization errors.
- Some quality assurance routines involve scanning a cylindrical phantom filled uniformly with radioactivity (e.g. ⁶⁸Ge, ¹⁸F).

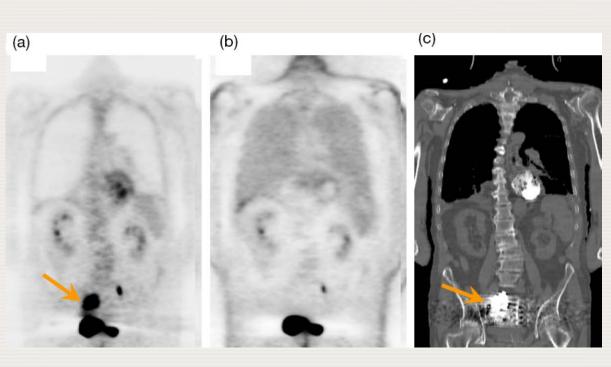
Attenuation correction artefact (a)CT attenuation corrected image of a patient showing a focal hot spot (indicated by the arrow). (b)Non-attenuation corrected image. The hot spot is no longer visible. (c)CT image showing a high density artefact from barium contrast pooled in the bowel.

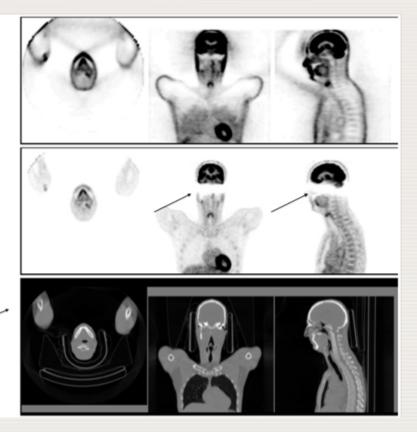
Truncation artefact

Top row: non-attenuation and scatter corrected PET images. Middle row: the corresponding slices with attenuation and scatter correction. Bottom row: CT images. Cold bands (arrows) in corrected images are due to truncation of patient's arms in CT images.

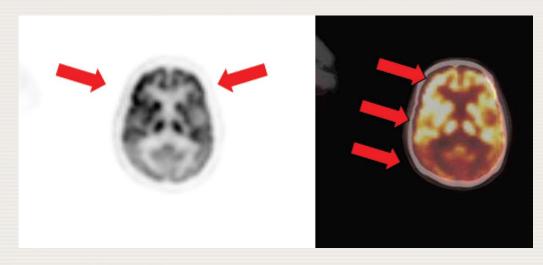
Misalignment artefact

Apparent asymmetrical uptake of [¹⁸F]-fluorodeoxyglucose in the brain (left) caused by the slight misalignment of the PET and CT images (right).

Alignment errors originating from patient motion are problematic and can have an effect on the medical interpretation of the image.

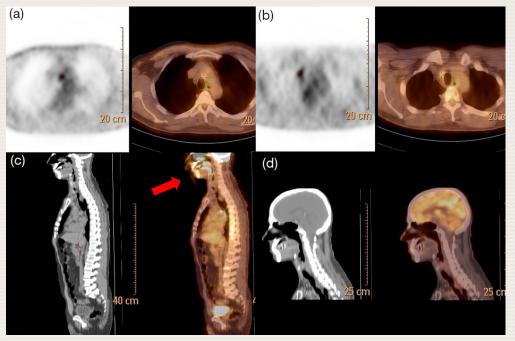
Mis-registration artefact

(a) A whole body PET/CT scan shows a point of focal uptake in the upper torso. (b)Separate head and neck acquisition of the same patient. (c)Whole body fused images show good registration of bladder, spine and heart, but a clear misregistration of the head (indicated by the red arrow). (d)In the separate head views good registration is observed.

- Patient motion artefacts can be easily missed and lead to an incorrect diagnosis.
- In whole body PET scans, it is possible for the patient to move during the acquisition so that some part of the anatomy is accurately registered between PET and CT, while in another part of the anatomy the registration is poor.

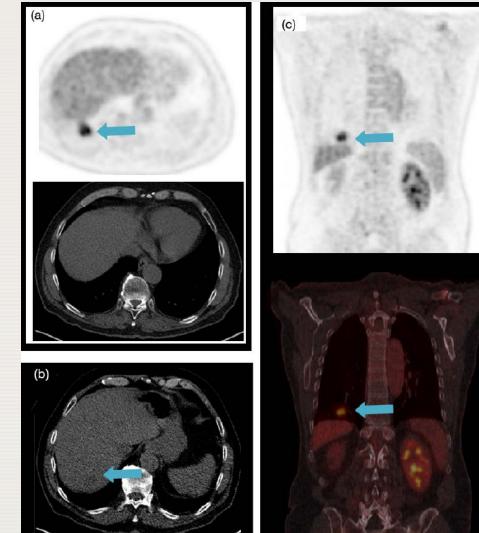
(a)Transaxial PET and CT images show a focal lesion, which appears to be in the lung.

(b)The CT image shows the same lesion appearing to be in the liver.(c)Coronal view of PET and fused PET/CT where the lesion appears largely displaced from the liver.

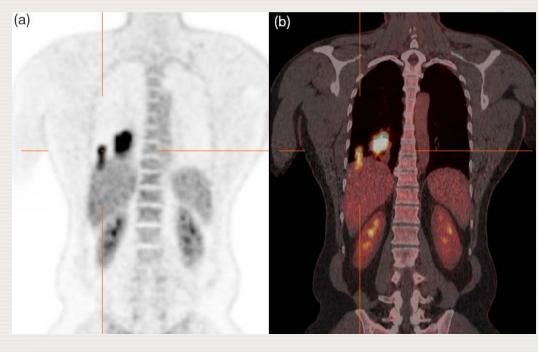
Mis-registration artefact

(a)Coronal PET image shows an area of focal uptake that appears to be both in the liver and in the lung, as well as another larger area that appears to be entirely in the lung.

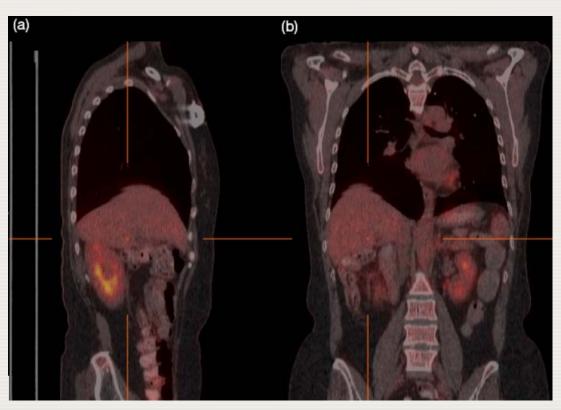
Respiratory motion artefact

(a)Sagittal image shows a step-like artefact in the liver.(b)The same step-like artefact is seen on the coronal views.

- Respiratory motion artefacts can also be seen in the CT image itself where the liver is not correctly rendered during reconstruction of the CT data because the patient is breathing during acquisition.
- This can be seen when there is a characteristic artefact repeated along the axis of motion, leading to unclear definition of organ boundaries.
